# BELZONA PROVIDES INTERNAL PROTECTION OF GEARBOXES

ID: 930

This is a typical small gearbox from a power plant within the refinery

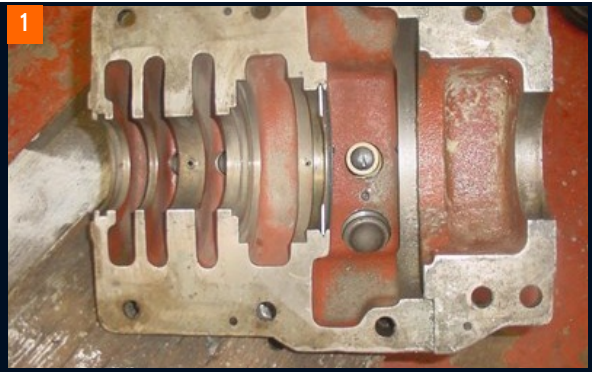
Original internal paint protection is flaking off and getting stuck in bearings and oilways. Loss of oil circulation can result in bearing damage and reduced efficiency.

1. Gearbox casing with damaged internal coating
2. Close up view of degraded paint coating
3. Close up view of Belzona 5891 coating
4. Completed coating on casing
