# BELZONA ELASTOMER RESTORES AN EXPANSION JOINT IN A PUBLIC SWIMMING POOL

ID: 9306

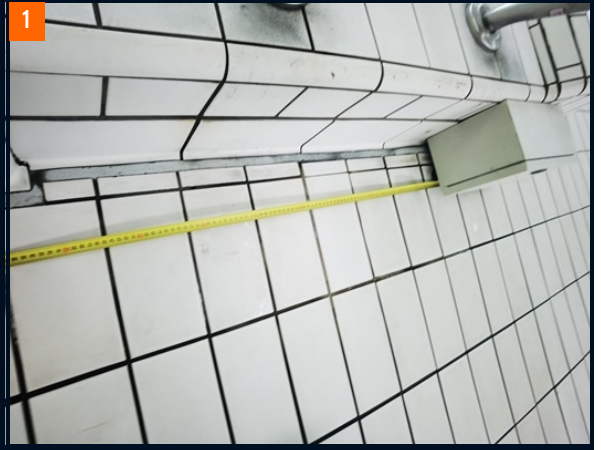
At a municipal swimming pool, an expansion joint around one of the pool basins was found detached from its support. Chlorinated water had started to attack the concrete slab, causing leaks through the concrete and bringing dampness to the equipment room in the basement. In addition, there was a greasy deposit from the old silicone expansion joints. This resulted in slipperiness which posed a serious risk of pool users falling over.

1. Measurement of the defective expansion joint in order to calculate the required quantity of product.
2. The application area was marked with tape to delimit the application area. A backer rod was inserted into the joint prior to the application of Belzona 2211.
3. Belzona 2211 filled the expansion joint, safeguarding the concrete structure underneath from further damage.

The old silicone expansion joint was removed and a grinder was used to prepare the surface for the application of Belzona. The area of defective joint was measured to calculate the product required to complete the application. Masking tape was utilised to properly mark and delineate the application area and to maintain a clean finish.
