# BELZONA PROTECTS LNG SPHERES

ID: 931

Pressurized LNG storage spheres.

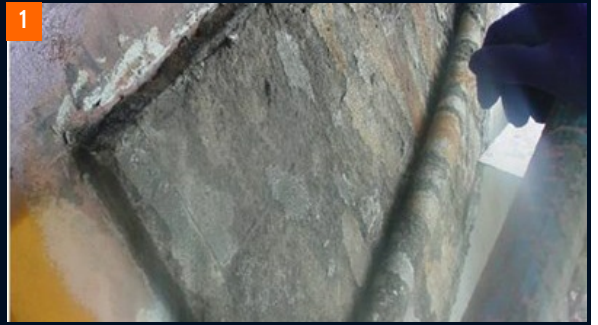
1. Foam glass block insulation being fitted
2. View of unprotected (South) Polar region
3. The far right sphere was coated 11 years ago and is still good
4. Five spheres coated with Belzona 3211 thus far

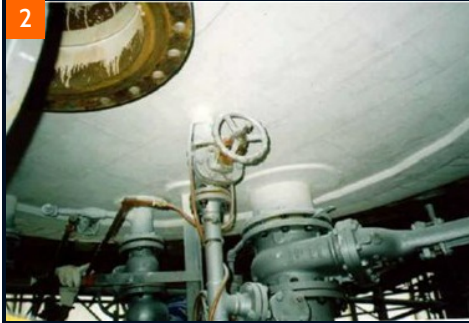
Water penetration through insulation causes severe Corrosion under Insulation.
