# BELZONA ENERGY-SAVING COATINGS IMPROVE PUMP EFFICIENCY

ID: 9312

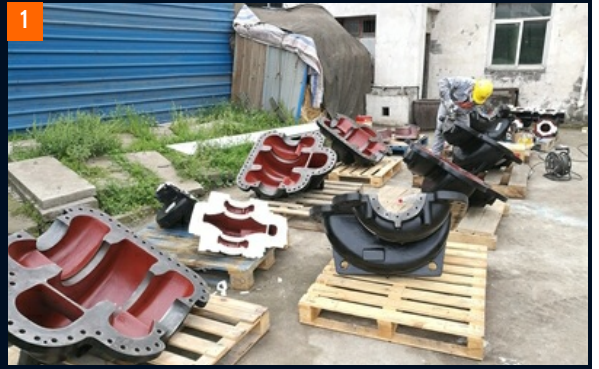
1. Before application
2. After surface preparation
3. During application of Belzona 1341
4. Application completed
