# BELZONA 1812 PROTECTS NEWLY FABRICATED SCREW CONVEYOR.

ID: 9314

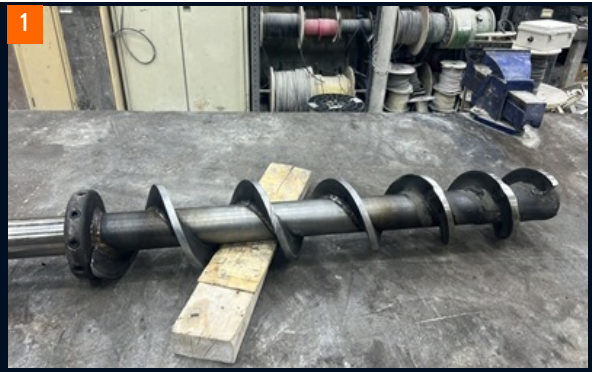
1. Screw conveyor before surface preparation.
2. After surface preparation.
3. Mixed Belzona 1812.
4. After application of Belzona 1812.

Surface preparation with MBX bristle blaster, grinder and solvent cleaning with Belzona 9111.
