# BELZONA REPAIRS CONCRETE WELL BASE

ID: 9317

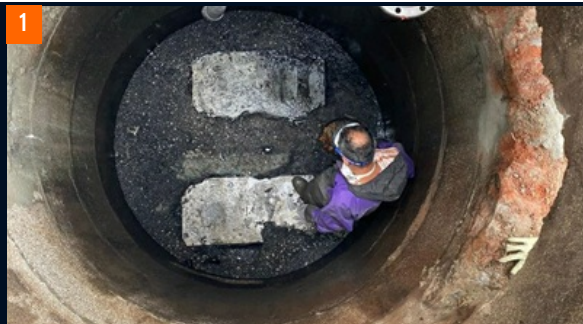
The concrete base was suffering from chemical attack caused by the waste in the process fluid. The bottom of the well was so severely damaged that the two pumps at housed there were in danger of detaching from their anchor points.

1. The damaged concrete area
2. Applying Belzona 4111 (Magma Quartz) and Belzona 5821
3. The finished application
