# BELZONA COATING PROVIDES CONCRETE PROTECTION & SMOOTH SURFACE FOR FISH FARM

ID: 9318

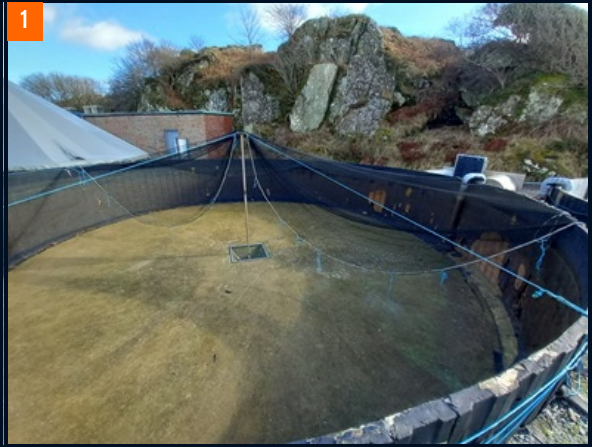
Concrete tanks had been installed & lined years previously with a Polyurea coating which had subsequently failed. This coating had disbonded in large areas & left the concrete open to degradation. The fish stored in the tank could suffer lacerations from the rough surface.

1. Failed coating
2. Belzona 5811DW2 application in progress
3. Completed application & filling in progress
4. Application in service 12 months

The existing coating was removed & concrete prepared mechanically. Any large gaps or joints were then filled before two coats of Belzona 5811DW2 was applied.
