# BELZONA REPAIR DAMAGE TO TECHNICAL TRENCHES AND FLOORS

ID: 9319

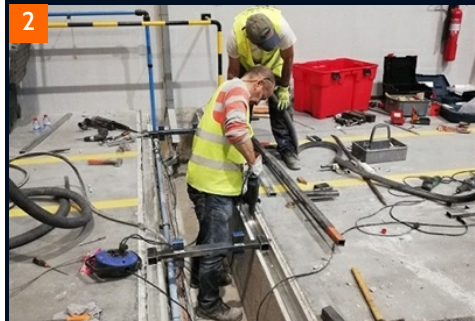
The problem is on the floor of a manufacturing warehouse. They have a problem on the floor of their blade factory, specifically in the joints of the technical trenches, which have metal covers along long lengths. These are found in many passage areas of the pavilion, being subject to impacts, scraping and support of loads from equipment and vehicles that circulate during production. With the movement of employees, equipment and vehicles, the metal rails at the joints are damaged, which can create dangerous situations for employees and damage to vehicles.

The repair procedure consists of removing the metal covers, removing the support rails (profile "Z"), opening recesses in the concrete to receive the new "L" shaped support rails (metal angle), applying Belzona 4111 (Magma-Quartz) to the base of laying and fixing them, filling the open spaces in the concrete with Belzona 4111 (Magma-Quartz) always with prior application of 4911 (Magma TX Conditioner) on the base and on the metal gutter "L", finishing the surface with Belzona 4111(Magma-Quartz) to be at floor level.
