# BELZONA 3412 ENCAPSULATES HUB CONNECTORS

ID: 9320

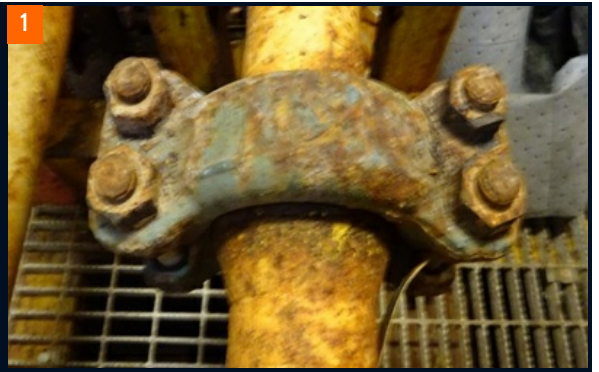
Hub connectors were experiencing corrosion in offshore environments. Within these connectors there are multiple voids where salt water can sit & cause corrosion.

1. Corroded hub connector
2. Surface preparation & Belzona 8411 applied
3. Bridging tape applied around voids
4. Two coats of Belzona 3412 applied
