# BELZONA SUPERWRAP 2 REPAIRS CHEMICAL SCRUBBER

ID: 9321

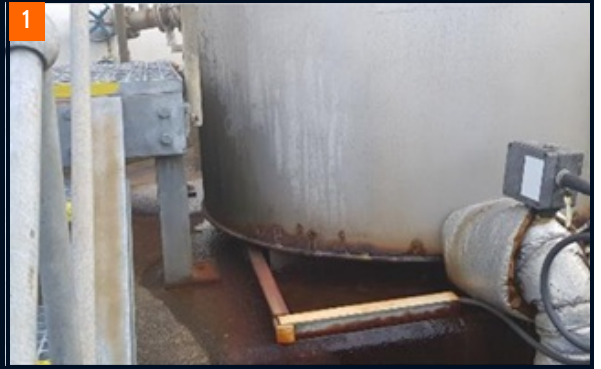
Chemical attack had caused through wall defects within a chemical scrubber. H<sub>2</sub>S reacting with water to form sulphuric acid was the main cause.

1. Corroded areas
2. Through wall defects
3. Close up
4. Completed application

The area was first prepared mechanically with an MBX Bristle Blaster. Belzona 1111 & small plates were then used to fair any corroded areas. Four wraps of Belzona SuperWrap II were then applied to reinforce the area.

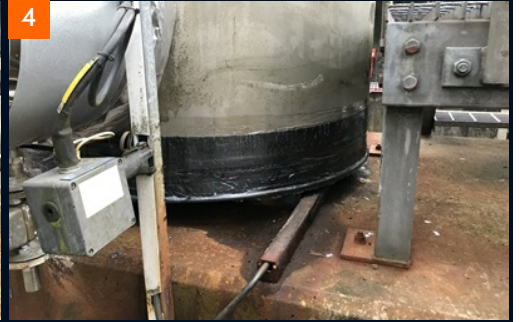
This repair was found to be cost effective, less hazardous & much less disruptive than the alternatives - welding or replacement. As of October 2023 other than discolouration from UV Chalking this repair is still in excellent condition
