# BELZONA SAVES CHILLER HEAD

ID: 9323

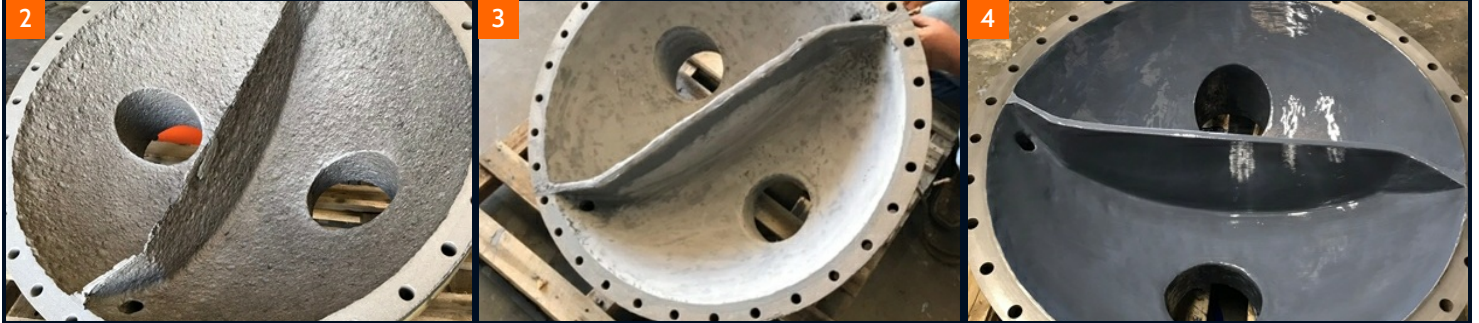
## PHOTOS

Chiller head was suffering from severe corrosion/chemical attack due poor water treatment.

1. Pre Job Inspection
2. Completion of Abrasive Blasting
3. Rebuild Complete with Belzona 1111
4. Complete Application with Belzona 1321

Equipment was repaired in 24-48 hrs. with no need for welding or hot work. Due to the fast turn around and repair cost of less than 25% of new, this application proved to be the best option for the client.

Equipment was abrasive blasted as per manufacture recommendations. Substrate profiles and chlorides were checked for compliance per manufacturer recommendations. Upon completion the application was successfully carried out per HEX-2 guidelines and returned to customer.
