# BELZONA SUPERWRAP II REPAIRS AND STRENGTHENS ASH CHUTES

ID: 9325

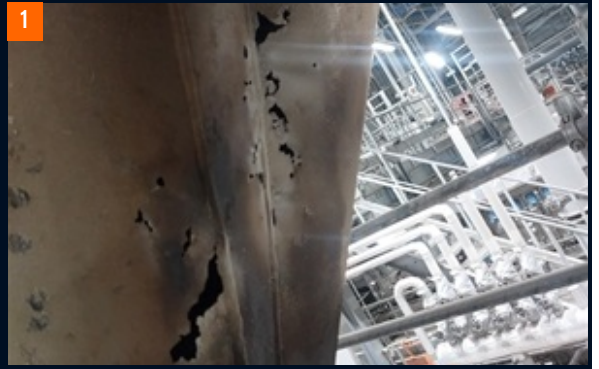
The customer burns non-recyclables and re-use the energy from the combustion. The ash left from burning comes down the chutes wearing holes due to sliding abrasion specifically on the elbows and joints where the ash has more contact.

1. Ash chute had worn due to sliding abrasion
2. Damaged area was bristle blasted to key profile
3. Belzona 1983 SuperWrap II is applied then Belzona 9382 release film is applied to consolidate application
4. Release film is removed and repair application is complete
