# BELZONA SUPERWRAP II APPLICATION ON MONEL 400 BELLOWS BETWEEN CONVOLUTIONS

ID: 9327

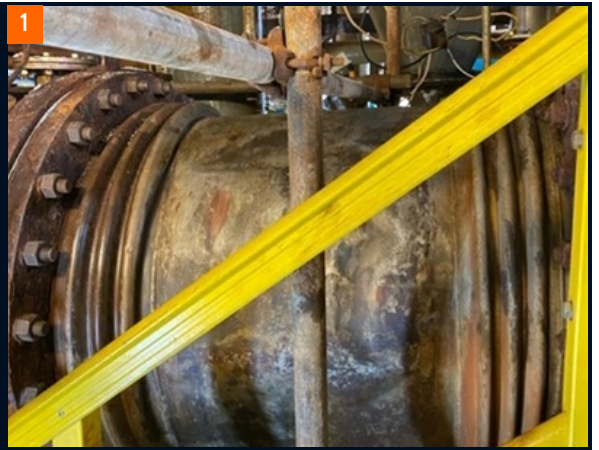
There was a small crack in the Monel which needed terminating and filling with Belzona 1511. The bellow also required strengthening.

1. Worn and cracked bellows between two convolutions
2. Crack in the bellows terminated and filled with Belzona 1511
3. Consolidation film wrapped around SuperWrap II application to ensure adhesion
4. Completed temporary solution for cracked and worn bellow

Surface preparation was done using manual tools removing rust and debris from the surface taking care not to penetrate the 2mm thick Monel Bellow. The crack was terminated and filled with Belzona 1511. Belzona 1983 was then applied to increase strength and durability of the bellow.
