# PROTECTION OF STAINLESS-STEEL SCRUBBER VESSEL FROM CHEMICAL ATTACK

ID: 9328

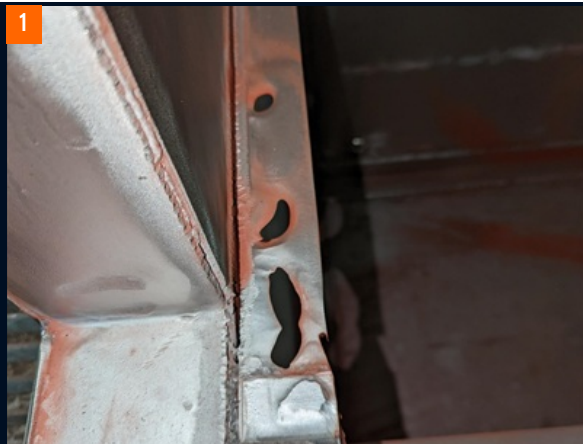
Newly fabricated stainless-steel scrubber vessels were put in service without a coating thinking the stainless-steel will provide enough protection. After 3 months they were having through wall defects in several parts of the vessel.

They had already invested in the fabrication of 4 of these vessels, so they needed to do something to protect their investment. The surface area that needed to be protected was around 2000 sq.ft per vessel. The contents in the vessel were very acidic and it got more concentrated at the bottom of the scrubber which is where they had the most problems.

1. Vessel initially after chemical attack.
2. After grit blasting.
3. Weld seams and gaps covered with Belzona 1111.
4. After application of two coats of Belzona 4311.
