# PROTECTION OF WASTEWATER CENTRIFUGE

ID: 9331

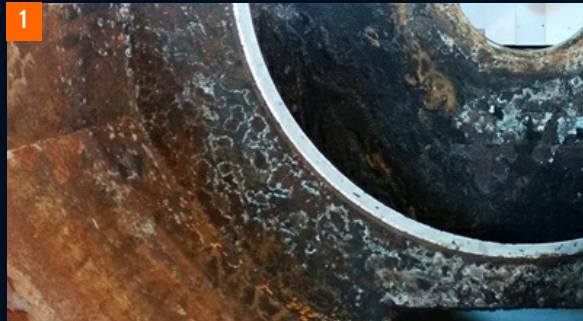
The centrifuge was suffering from erosion-corrosion and scale buildup. They needed a product that would protect the equipment but also help reduce the buildup and improve the efficiency of the equipment.

1. Original corroded substrate
2. During surface preparation
3. First Coat Application
4. Finished application
