# SOLVENTS PUMP REPAIR BELZONA 1321 AND BELZONA 1121

ID: 9335

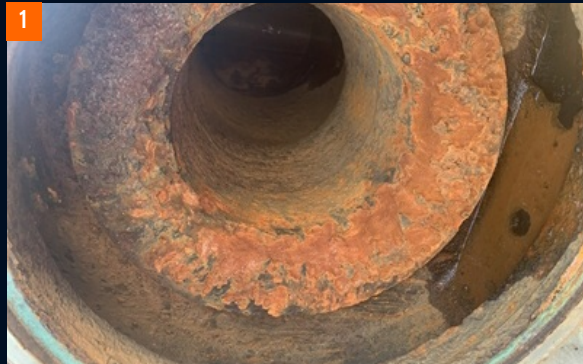
Drainage issues inside facility was causing backups. While dredging canals client took opportunity to improve pump for efficiency.

1. Close up of pitting BEFORE
2. Pump in place prior to improvements
3. Pump coated in Belzona

Abrasively blasted interior of parts as per specification.  
(Angular Abrasives used to achieve 3 mil angular profile as per specifications.)

Made repairs at the inlet and filled in any pitting using Belzona 1121  
Applied Belzona 1321 to interior parts as per product manufacturers recommendations.
