# PROTECTION OF ELBOWS IN MUNICIPALITY POTABLE WATER PLANT

ID: 9336

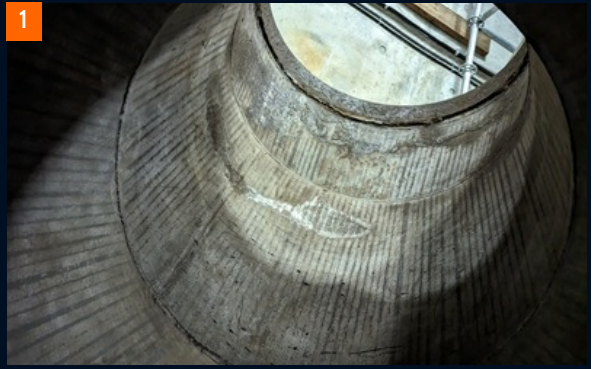
Pipe elbows had a concrete liner which was very deteriorated and at times concrete chunks became loose in the system which was unacceptable.

1. Elbow with deteriorating concrete liner.
2. Rebuilding deep pitting with Belzona 1111.
3. Application of stripe coats of Belzona 1341N.
4. Elbow after application of second coat of Belzona 1341N.
