# PIPE IN A WASTEWATER PUMPING STATION REINFORCED WITH BELZONA SWII

ID: 9337

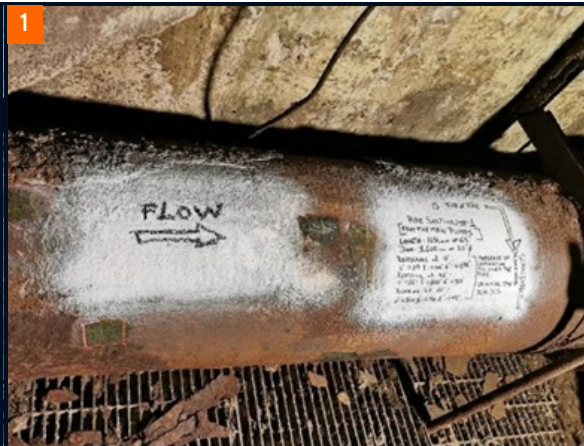
The pipe section was suffering from general external corrosion. The pipe had become weakened from severe metal loss. This pipe section never got flooded nor exposed to immersion conditions. Yet, there was a lot of moisture in the environment.

1. Corroded pipe with severe metal loss
2. Blasted pipe and measuring environmentals
3. Resurfaced with Belzona 1121
4. Application completed with SWII reinforcement and coated flanges
