# REFURBISHMENT AND PROTECTION OF WATER-POLYMER MIXTURE TANK FROM FURTHER CORROSION

ID: 9338

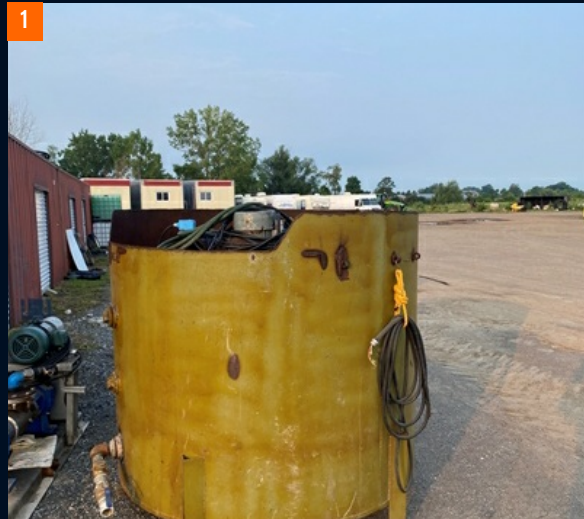
Tank was very badly corroded and required refurbishment and protection

1. Tank exterior prior to application.
2. Tank interior prior to application.
3. After sand blasting and application of two coats of Belzona 5811

All the elbows were grit blasted to SSPC SP10 and two coats of Belzona 5811 were applied.
