# CHEMICALLY DAMAGED FLOOR REBUILT AND PROTECTED WITH BELZONA

ID: 9339

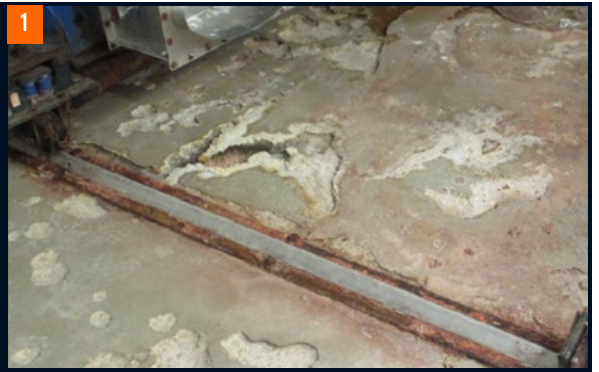
Manufacturing plant that processes Bio-based succinic acid was having issues with their floors. Dry process material of Bio-based succinic acid was being spill onto the concrete floor and during floor washing operations, water activated the acid and this one started to attack the concrete.

1. Floor damage caused by Succinic Acid
2. Applying second coat of Belzona 4311
3. Second coat of Belzona 4311 around floor step up's and piping equipment through floor.
4. Finished floor coating Belzona 4311

The damaged concrete was washed and decontaminated. Missing concrete areas were refurbished and smooth out. 2coats of Belzona 4311 (Magma CR1) were applied to prevent future deterioration of the concrete via chemical attack.
