# BELZONA SEALS WAREHOUSE FLOOR

ID: 934

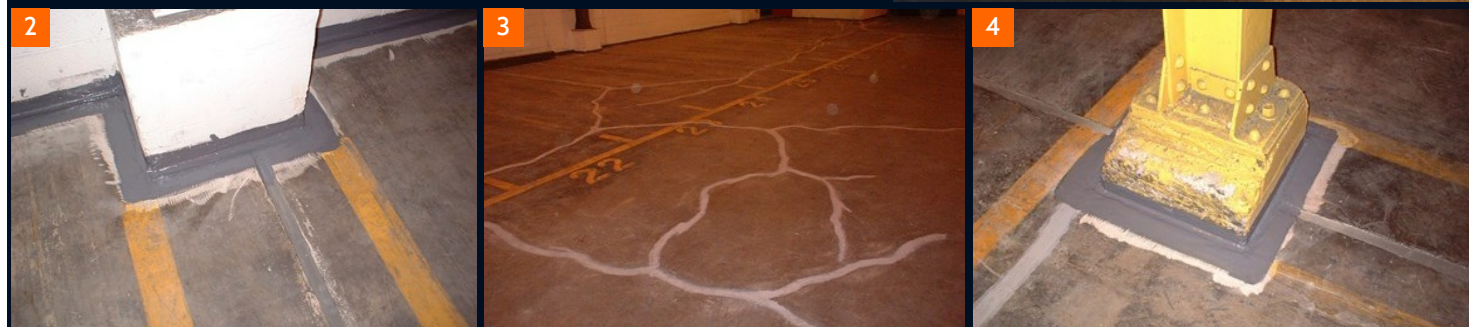
## PHOTOS

Chemical spills however quickly cleaned up could contaminate ground-water. Facility near two major rivers. Floor had many cracks and gaps around wall to floor detail.

1. Floor to wall joint before sealing
2. Sealing warehouse floor-expansion joints
3. Sealing joint around perimeter
4. Repaired/sealed cracks with Belzona 4131

Application was carried out following Belzona Know-How System Leaflets FPA-6 and TCC-15. Cracks were chased out before being filled and sealed.
