# REPAIR OF WEAR AND THROUGH WALL DEFECT ON VOLUTE OF PUMPS AND PROTECTION OF PUMPS FROM FURTHER CORROSION

ID: 9340

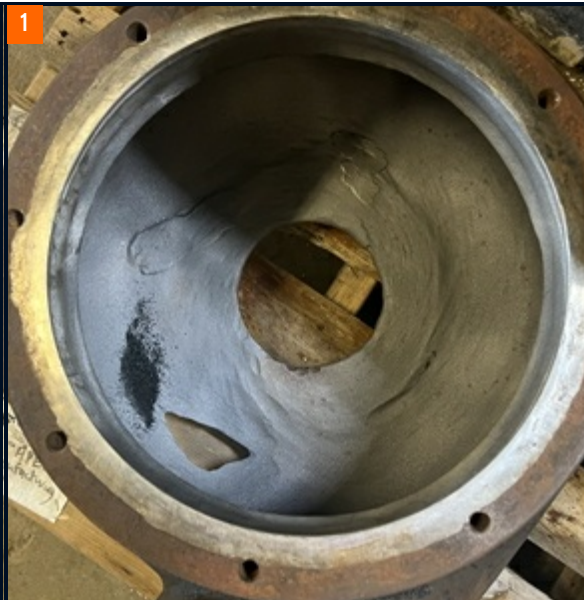
Through wall defect and wear in pump caused by sewage and particles in wastewater was to be repaired and lined with intention of getting more lives out of the pumps.

1. First pump with through wall after grit blasting.
2. Second pump with wear after blasting
3. After rebuilding wear on pump with Belzona 1111.
4. First pump after plate bonding with Belzona 1111 and both pumps lined with Belzona 1321.

Pumps were grit blasted to SSPC SP10. First pump was rebuilt, hole repaired using a metal plate and entire interior covered with Belzona 1111. Wear on inside of pump 2 also rebuilt using Belzona 1111. Afterwards, two coats of Belzona 1321 were applied to both pumps.

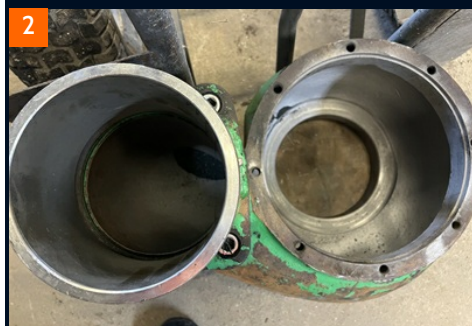
Pumps was badly worn due to particles in sewage and wastewater. Therefore, customer needed to not only repair but protect pumps from future occurrence.
