# WIND TURBINE BLADES LEP PROTECTED WITH BELZONA 5721

ID: 9341

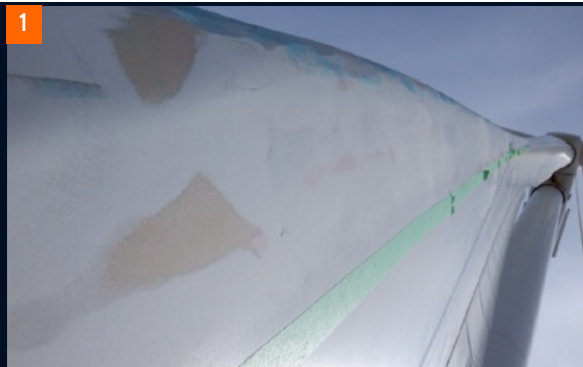
1. Repairs and Sanding complete
2. Ready for degreaser and cleaner
3. Belzona 5721 application
4. Inspection after 7 months of back in service

Before the application of Belzona 5721, the surface of the LEP was cleaned and sanded. Defects and areas that needed rebuild were repaired. Once a clean and even surface was achieved, Belzona 2911 (Elastomer QD Conditioner) was applied to condition the surface and allowed to become touch dry. Then, one coat of Belzona 5721 was applied to the thickness of 20 mils. The product was allowed to cure before putting the turbine back in service.

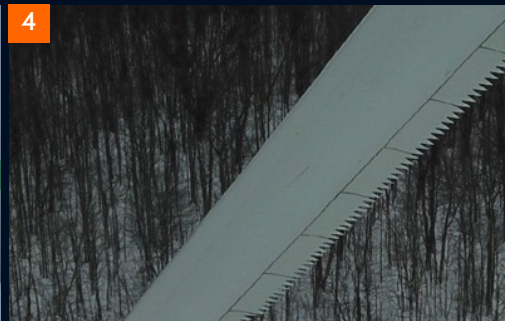
The product was inspected via drone after 7 months in service, and the product appeared to be intact with no signs of wear, chalking or peeling.
