# WEAKENED PIPE REINFORCED WITH PLATE BONDING AND SW

ID: 9342

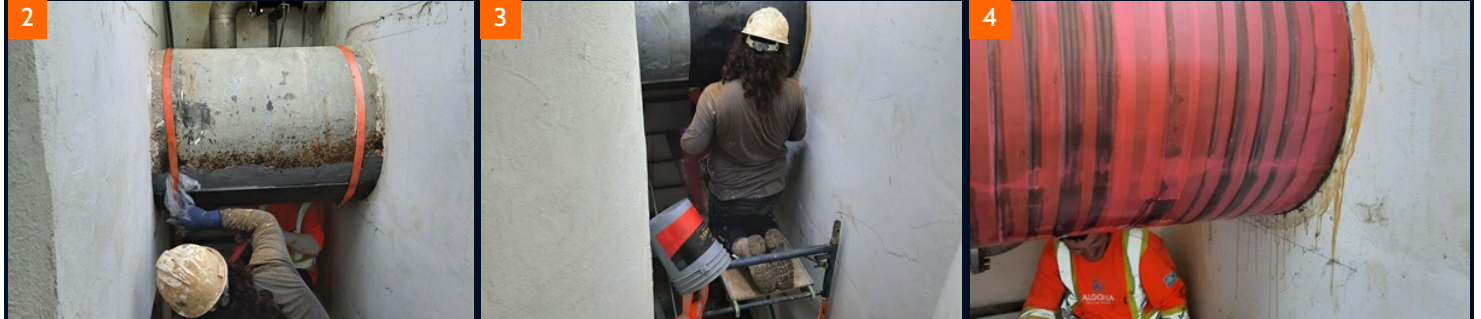
A pipe in a wastewater plant needed had suffered from external corrosion and metal loss over the years.

1. Defective pipe
2. Plate bonding over the most critical area
3. 1st layer of Belzona SWII
4. Complete repair after consolidating with the release film to be later removed

The pipe was so deteriorated that they were concerned that abrasive blasting the bottom of the pipe will puncture the pipe and create through wall defects. It was decided to do a plate bonding with a surface tolerant product as an initial reinforcement before further reinforcing with SWII.

First, the pipe was prepared as best as possible. The we did a plate bonding repair with Belzona 1161 to protect the bottom section of the pipe. After, we grit blasted the rest of the pipe and reinforced the rest of the pipe with Belzona Superwrap II.
