# REVIVING GRAY AND BLACK TANKS INSIDE A MARINE VESSEL WITH BELZONA SOLUTIONS

ID: 9343

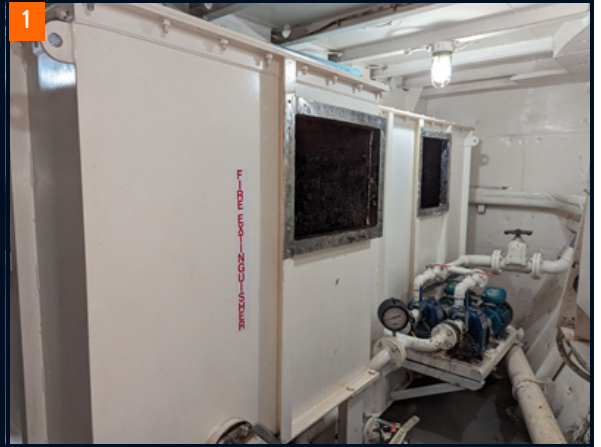
The gray and black tanks inside the marine vessel were suffering from coating failure and corrosion issues. The main flange also required repair from wear.

1. Tanks before surface preparation.
2. After surface preparation.
3. Gray Tank After application of two coats of Belzona 5811.
4. Black Tank After application of two coats of Belzona 5811.

After solvent cleaning, and then with the use of a power tool, tank internal surfaces were prepared to SP11. Flanges were also rebuilt using Belzona 1111. Two coats of Belzona 5811 were then applied.
