# STEMMING AND SEALING HIGH VOLTAGE TRANSFORMER OIL LEAK

ID: 9344

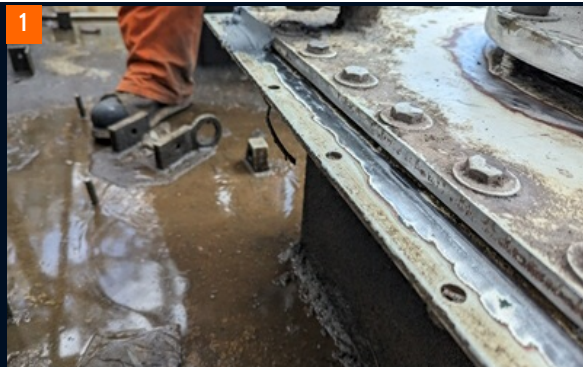
1. Transformer after surface preparation.
2. Leaks stemmed and sealed with Belzona 1161
3. Coating to avoid permeation.

Surface was wiped clean using solvent / degreaser and then prepared according to SP11 standards. Surface was wiped clean and leak sealed using Belzona 1161 and 9341. Afterwards, two coats of Belzona 5831 was applied.
