# EMERGENCY REPAIR ON ESCALATOR HANDRAIL WITH BELZONA PRODUCTS

ID: 9346

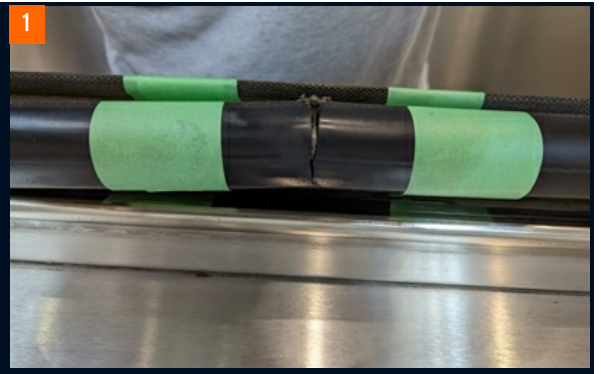
The handrail of an escalator had 2 defective areas. The side of the rubber was ripped and presented a potential safety hazard for the mall customers.

1. Damaged belt
2. Mixing of Belzona 2311
3. Removing masking tape after applying 2311
4. Completed repair

The surface was roughened up and degreased. Then conditioner Belzona 2911 was applied and allowed to dry. The repair was then completed with Belzona 2311 with reinforcement tape 9341.
