# PROTECTION OF NEW FLYGT PUMP

ID: 9348

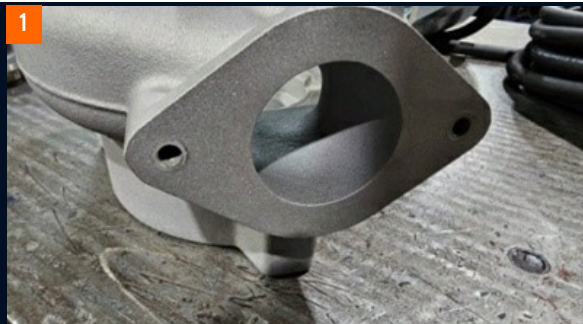
1. Pump after grit blasting.
2. Casing after grit blasting
3. After application of Belzona.
4. After application of Belzona.

Pump was grit blasted to standard SSPC SP5 and coated with Belzona 1321.
