# BELZONA REBUILDS SEAL FACE ON RAW MILL AT CEMENT PLANT

ID: 935

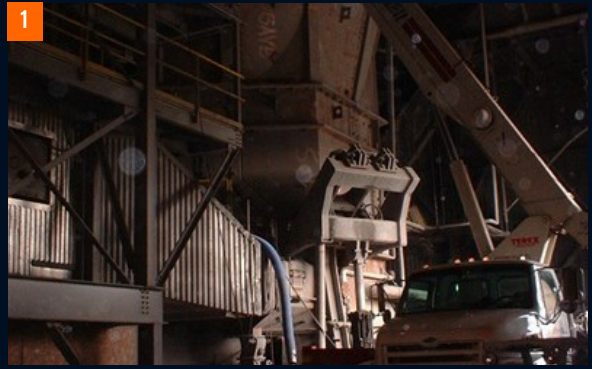
1. Raw mill overall size
2. Worn seal area on rotating table
3. Belzona 1812 applied and new felt seal and holder installed
4. Another general view of the mill

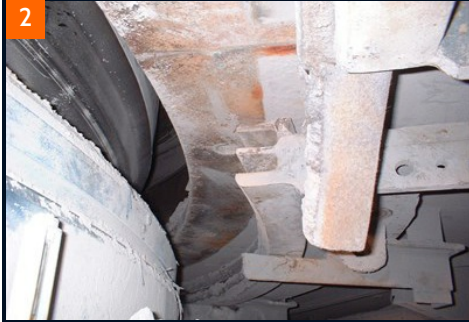
Abrasion from the felt seal and limestone wore this major component of the mill.

Application was carried out in accordance with Belzona Know-How System Leaflet SHM-13. Limited access only allowed hand grinding for preparation followed by application of the Belzona® 1812 by trowel.
