# BELZONA SMOOTHS OUT COMPETITION

ID: 9350

## PROBLEM

The expansion joint had been damaged and breaking up grout from North to the west end surgical area.

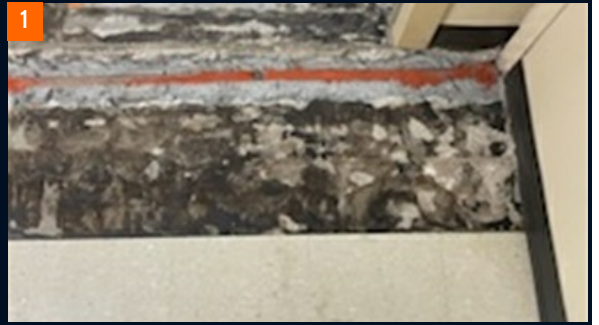
1. Removing existing expansion joint
2. After grout was removed
3. Finished smooth ride
4. completed smooth ride application

Removed old expansion joint and chipped out grout around area. Grinded down concrete to make a smooth transition. Built up concrete with Belzona 4111, created expansion joint with Belzona 2221 and coated transition with Belzona 5231
