# BELZONA SF6-FIX SYSTEM STOPS SF6 LEAK

ID: 9351

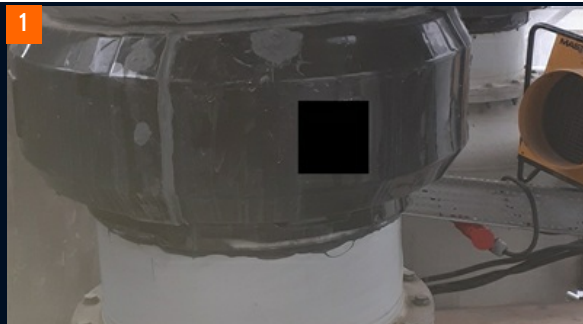
1. Previous repair was leaking SF6 gas around the edges of the bond area.
2. Previous repair removed, Substrate prepared using bristle blaster and membrane installed.
3. Belzona 7311 applied to breather membrane with Belzona 9341 incorporated. 5x layers of Belzona 9371 utilising Belzona 1981 resin.
4. SF6 containment completed with vent pipe left open until full cure is achieved. This is then capped off following full cure.
