# LEAKING POROUS WELD REPAIR

ID: 9352

Weld Joint on stainless steel pipe was leaking due to a porosity and slag inclusion

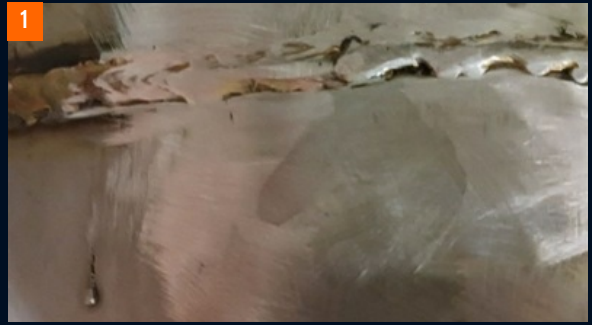
1. Repair area preparation completed
2. Belzona 1111 mixed
3. Application of Belzona 1111
4. Application completed

Preparation was completed in-way of using a grinder with a 80 grit sanding pad, than cleaned with Belzona 9111. Next the Belzona 1111 repair composite was mixed and applied well into the preferred area. Using a piece of Belzona 9341 Reinforcing cloth was wetted out and applied over the repair area with a further layer of Belzona 1111 until the cloth was covered.
