# DIFFUSER RING RESURFACE AND COATED WITH BELZONA

ID: 9353

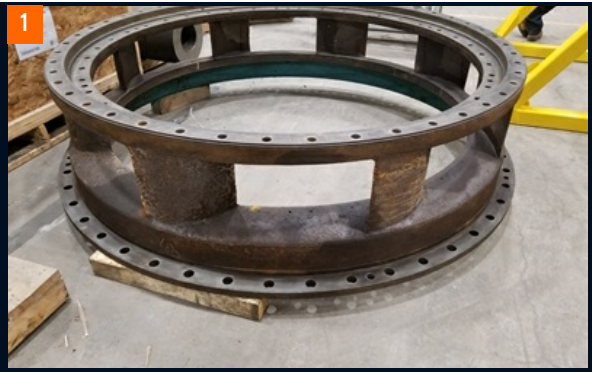
Diffuser ring was corroded and certain areas were worn out and needed to be resurfaced.

1. Initial state of the ring.
2. Resurfacing with Belzona 1111.
3. 1st coat of Belzona 1341.
4. After application of 2nd coat.
