# INTERNAL LINING OF VACUUM DEAERATOR

ID: 9354

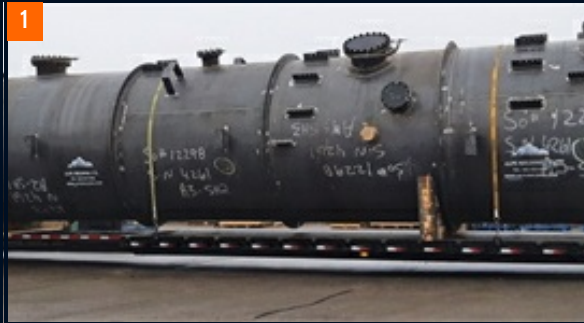
1. Outside look at the vacuum deaerator.
2. Internals before application.
3. Internals after coating application.
4. End cap coated.
