# PUMP BEARING HOUSING REPAIR IN SITU

ID: 9355

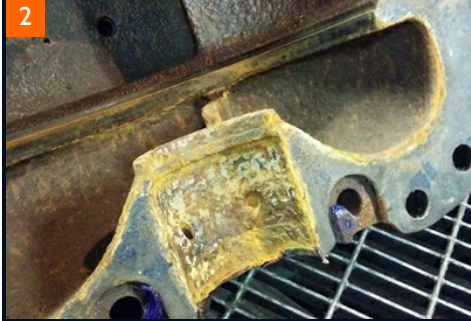
Upon removal of the top casing, the pump was inspected. It was determined that the bush seating was suffering from corrosion and wear and needed to be rebuilt.

1. Outside look at the vessel
2. Damaged bearing housing
3. Belzona 1121 applied with formers in place
4. Look at the bearing housing once the former was removed

A light weight former was pre-fabricated, which was coated with Belzona 9411 (Release agent) to allow for easier disassembly once the rebuilding material has cured. The damaged area was manually ground and cleaned prior to the application of there building material. Belzona 1121 (Super XL-Metal) was used as the rebuilding material. The product was mixed and applied over the damaged area and then the former was pressed against the product to achieve the desired dimensions. The former was removed after the product was fully cured.
