# REPAIRING THE SHAFT OF A VINTAGE AIR HANDLER UNIT, AGED OVER 50 YEARS

ID: 9356

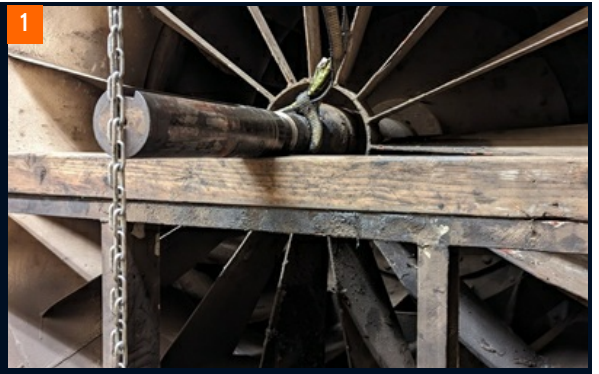
Tackling a demanding repair job on an air handler unit presented a unique challenge: its placement in a notoriously inaccessible area rendered removal or replacement nearly impracticable as it was located at a more than 50-year-old facility.

1. Air handler Unit
2. Shaft after surface preparation
3. In-situ repair with 3D mold
4. Successful repair
