# BELZONA REBUILDS AND RESURFACES SHIPS TAIL SHAFT

ID: 9357

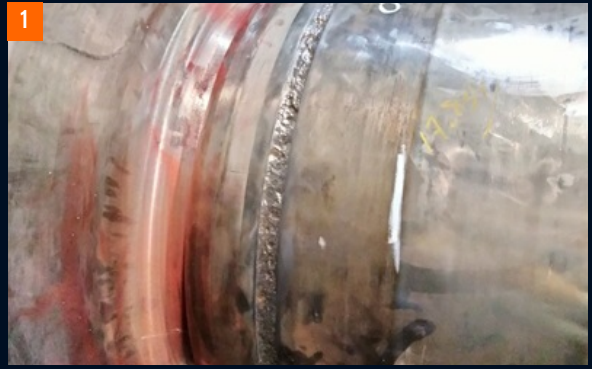
1. Shaft preparation completed for rebuilding
2. Belzona 1111 application finished and ready for machining
3. Application of Belzona 1331 second coat
4. Shaft repair areas waiting on cure times so the machine shop can machine to the correct measurements.

Preparation was carried out using hand tooling, cleaned using Belzona 9111 as per the Instruction For Use (IFU) the products, Belzona 1111 was used for rebuilding and Belzona 1331 was used for a protective coating for it offers erosion and corrosion resistance and can be applied with a heavy single coat without sagging.
