# BELZONA SUPERWRAP II RESTORES PIPE INTEGRITY

ID: 9360

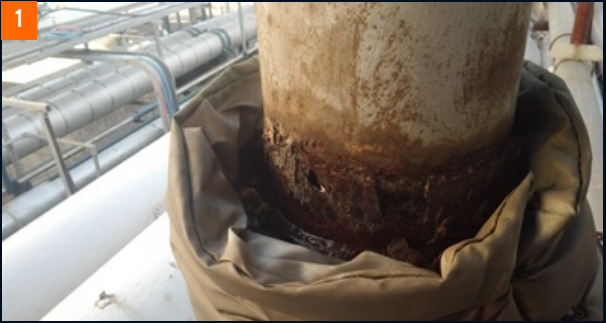
A section of cooling water pipework was corroded through wall. A repair was required to prevent any leaks occurring and to restore strength to the pipework.

- 1. Corroded pipe section
- 2. Completed repair with Belzona 1981 SuperWrap 2 installed

The area was cleaned & roughened using angle grinders. Belzona 1212 was then applied to fill any large pits & to fair the surface. Four overlapping wraps of Belzona SuperWrap II were then applied & consolidated with Belzona 9382
