# SUBMERSIBLE MULTI STAGE PUMP REPAIRS AND COATINGS

ID: 9361

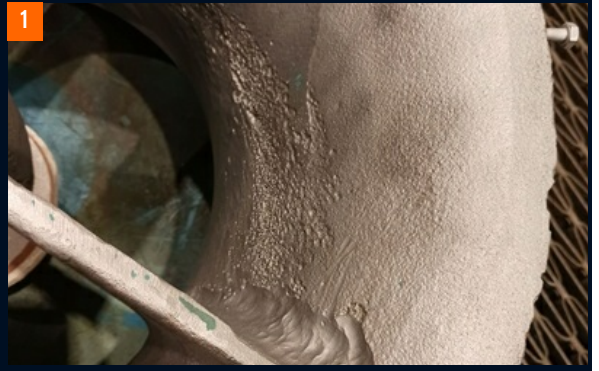
1. Preparation in progress for rebuilding of pumps bowls and suction bell as per the IFU
2. Repaired areas of pump bowls using Belzona 1121
3. First coat of Belzona 1321
4. Second coat of Belzona 1321

pumps were dismantled by the site's maintenance team and all parts of the equipment received grit blasting and than cleaned using Belzona 9111. All areas requiring rebuilding was completed using Belzona 1121 due to the extended working life and the overcoat window time. Belzona 1321 was used for the internal coating and Belzona 4311 was used on the externals of the equipment.
