# BELZONA SAVES HOSPITAL AHU CONDENSATE PAN

ID: 9362

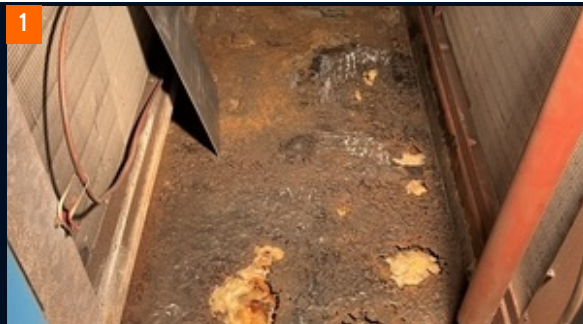
Water condensing on the cooling coils would trickle down to the collection pan. Over the years the pan corroded to the point where large holes developed. Water would leak out through the bottom of the AHU and then down to the hospital operating room below causing disruptions and potential health/mould problems above the ceiling tiles.

1. Surface preparation to reveal holes in pan and ready for cold plate bonding.
2. Steel doubler plates bonded into place with Belzona 1161. Edges of pan chamfered with additional Belzona 1161.
3. First coat of Belzona 5831LT White applied.
4. Second coat of Belzona 5831LT Grey applied.

The entire pan was power tool cleaned to SSPC-SP11 bare metal cleanliness using grinders and wire wheels. The pan was then degreased with MEK. Several 6mm thick steel plates were measured and cut, then bonded into place using procedure TCC-1 with Belzona 1161. Once Belzona 1161 cured the entire pan was coated with 2 coats of Belzona 5831LT for best adhesion to a power tool cleaned surface, and anticipated humid environment.
