# BELZONA 5811 EXTERIOR/INTERIOR COLUMNS AND HEAD BELZONA 5811/5111 EXTERIOR 1341 WET INTERIOR PITTING FILLED WITH BELZONA 1121

ID: 9363

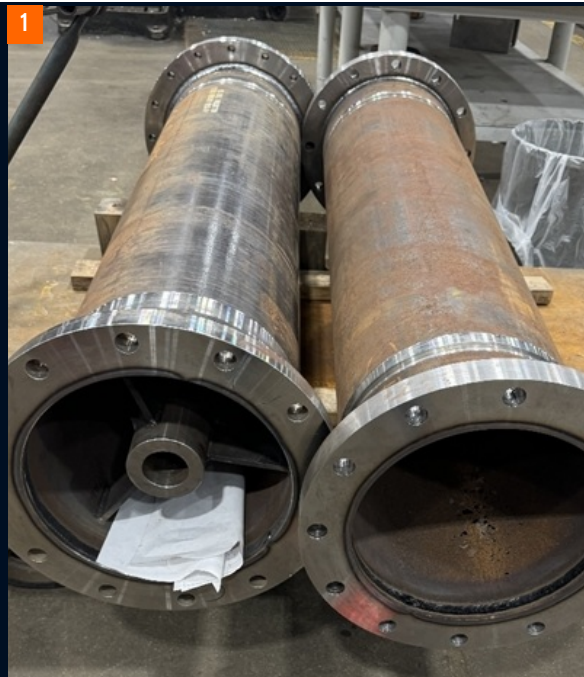
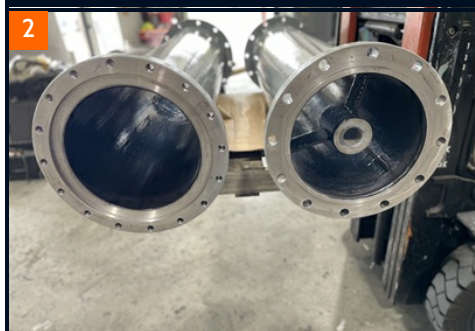
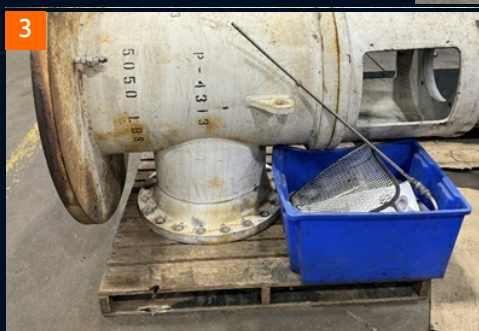
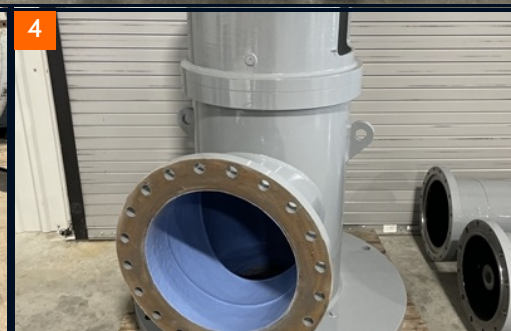
Extreme pitting and loss of integrity

1. Columns Before
2. Columns After Belzona 5811 External/Internal
3. Head Before
4. Head After Belzona 5811/5111 External/1341 Internal

Abrasive blast internals and externals to SSPC PC 10 (3 mil min. angular profile) as per product manufacturer's recommendations.  
-Rebuild pitted areas using Belzona 1121.  
-Apply Belzona 5811/5111 to exterior and Belzona 1341 interior wet areas of listed parts as per product manufacturer's recommendation as listed.
