# PLATE BOND TO REPAIR AND PROTECT A CHUTE THAT HAS POWDER LIME BLOWN THROUGH IT

ID: 9366

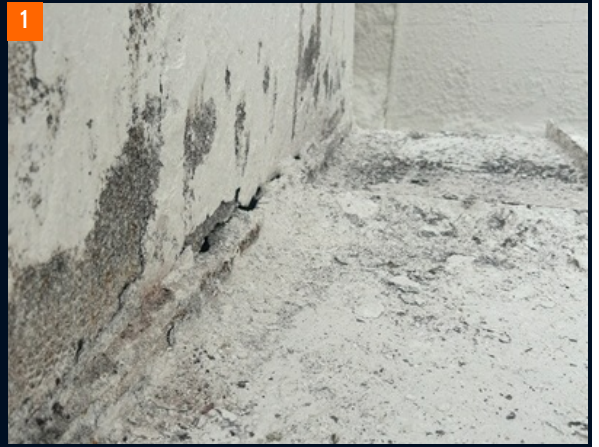
The chute which carries powder lime had a hole in it they needed to repair in place while adding abrasion protection with Belzona 1812

1. Area before being cleaned and prepared for work.
2. Area being prepared for application of Belzona 1212 and plate bond with Belzona 1812.
3. Belzona 1812 being applied to prepared plate to get ready to bond it to the chute.
4. Job complete. Belzona 1212 and reinforcement cloth used to repair holes then a plate was boned with Belzona 1812 for abrasion protection.
