# BELZONA REFURBISHES LABORATORY WORKTOPS

ID: 937

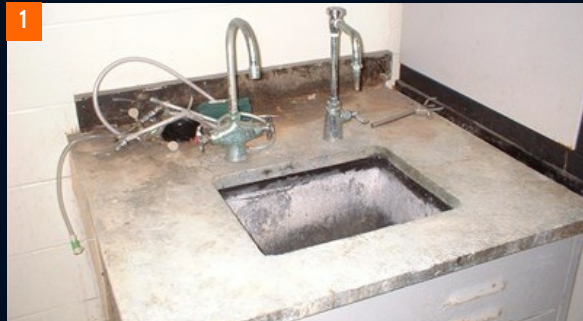
Severely degraded counter tops needed to be resurfaced with a chemically resistant coating.

1. Sink in lab before work
2. Fume cupboard before work
3. Sink after coating
4. Counter top after coating

Application carried out in accordance with modified Belzona System leaflet FPA-3. Special care was taken to clean sand the surfaces. Belzona® 5811 applied over-thickness with a trowel to create a self levelling coat.
