# BELZONA SUPER WRAP ON A CONCRETE STAND FOR A PIPE AT A POWER STATION

ID: 9377

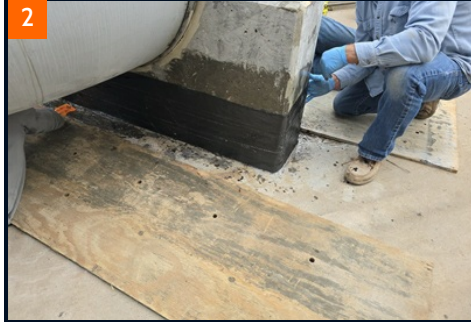
The concrete pedestal holding up a pipe formed a crack over the years of exposure to the elements.

1. Power plant water cooling pipe pedestal and crack
2. Superwrap II starting being applied
3. Second wrap on pedestal
4. Final picture with consolidation tape

Cracks were injected and pinned before a two wrap system was applied.
