# PREMIERSHIP FOOTBALL CLUB STAND STILL STANDING!

ID: 9379

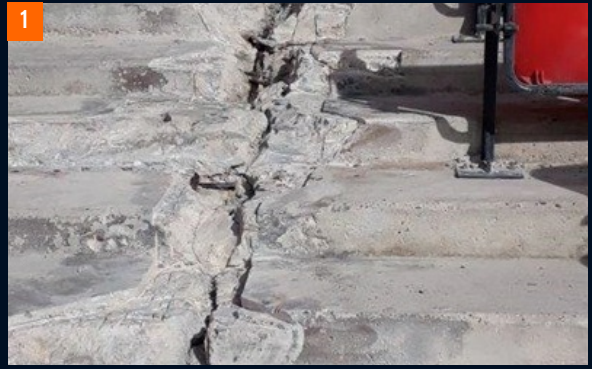
Two parts of the main football stand had been moving together over a period of 15 - 20 years. On many occasions, the resulting eruptions were locally repaired using everyday repair materials. This was a constant battle and would never really cure the issue.

1. The original issue, with all loose and friable removed, ready for repairs to be made and a 30mm gap to be created
2. The shoulders have all now been made good and is ready for the bridging tape and the application of the Belzona 2211
3. The completed repair and installation of the "accumulator gap"
4. 4 years later and the repair is as good now as it was at installation, with no issues created by movement and no further damage to the main football stand

Break out loose and friable

Apply release agent to 30mm wide boards to great gap

Apply Belzona 4911 to all concrete repair target areas

Remove 30mm boards

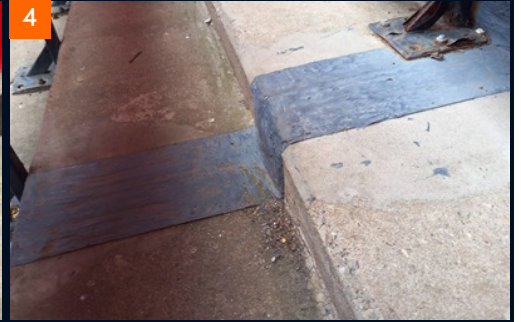
Belzona came along, carried out the works and it hasn't been an issue since
