# BELZONA FACILITATES CHANGE OF USE

ID: 938

Un-utilized Diesel Storage tank required for Chemical storage.

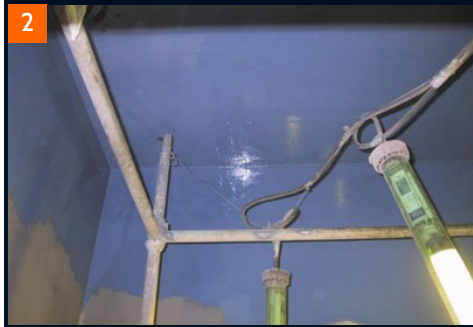
1. Top half of the vessel blasted ready to start coating
2. First coat of Belzona 1341 being applied
3. Top half of the vessel coated with 2 coats Belzona 1341, note masking tape in position for the reblasting of the bottom half of the vessel
4. Bottom half of the vessel with the first coat Belzona 1341 applied

Application carried out in accordance with Belzona Know-How System Leaflets TCC-5 and VPF-13. All nozzles had Belzona inserts fitted and all the flange faces were formed with Belzona® 1111.
