# SEALING OF LEAKS TO SF6 GAS CIRCUIT BREAKER IN LARGE SUBSTATION

ID: 9380

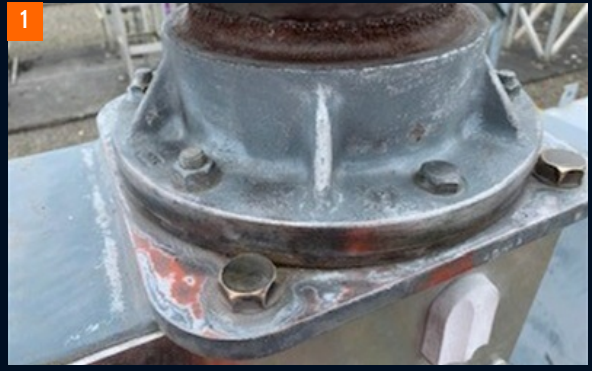
1. Prepare area with emery paper/ wire brush making surface area as rough as possible.
2. Initial wetting out with a short bristled brush to coat all target areas
3. Cover nuts/bolts with belzona filled caps Wrap with bandage around whole area, overlapping and patching where necessary.
4. Build up Belzona product, ensuring no air pockets remain. Product given a week to cure before 5 bar restored to the Gas Circuit Breaker

Abrade the target area as much as possible
