# FLANGE & FASTENINGS LEAKAGE

ID: 9381

## PROBLEM

High temperature steam leaks and loss of vacuum at the interface of the two mating flanges

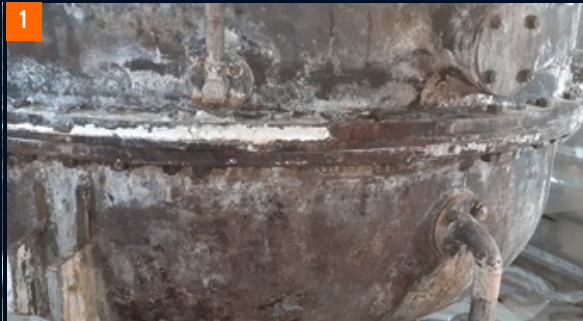
1. Condition of vessel circumferencial flange
2. Surface preparation by grit blasting
3. Bolt caps filled with Belzona 1511 and general filling of flange interface.
4. Finally full encapsulation of repairs using Belzona 5811
