# ONE DAY TURNAROUND FOR BELZONA FLOOR REPAIR AT IRON ORE MINE

ID: 9382

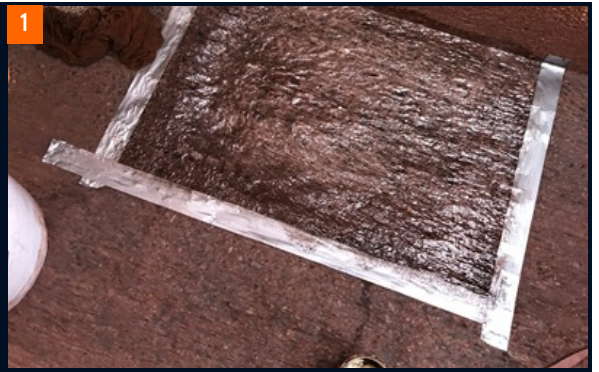
1. Smaller are prepared ready for Belzona application
2. Belzona 4131 applied to damaged area.
3. Application in progress
4. Completed repair with Belzona 4131 in service for 5 years

Surface preparation was carried out by hand as the substrate was concrete with blue stone in it. Belzona 4911 (Magma TX Conditioner) was first applied to the area, and then Belzona 4131 (Magma-Screed) one metre at a time. Distributor's own application team carried it the application on site.

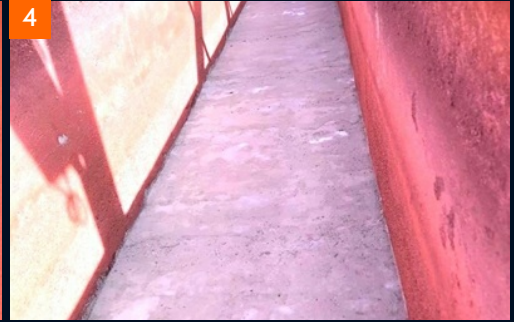
These initial repairs have been in service for 4-6 years and they show no signs of wear.
