# BELZONA NOZZLE INSERT AND CORROSION PROTECTION FOR DEMIN VESSEL

ID: 9383

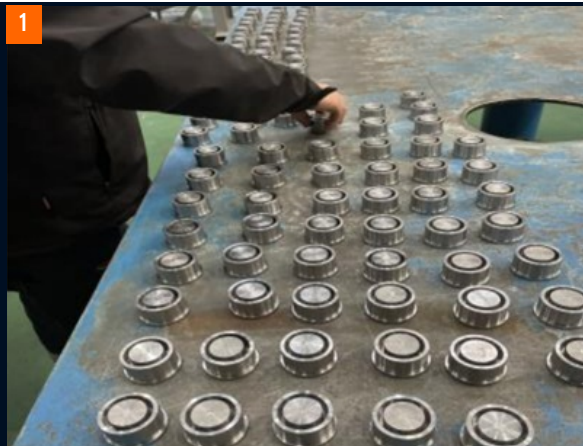
1. Metal former used to case nozzle inserts
2. Application in progress of the nozzle inserts
3. Nozzle bonded in place with Belzona 1311
4. Completed application

This vessel was approximately 7metres long and 3metres diameter. There were two divider plates, equally spaced inside the vessel. Each divider plate had 420 holes in the plate to accommodate filters. The distributor oversized the holes by 4mm per side and insert and bonded a Belzona nozzle into place to eliminate the corrosion at these points. The Belzona was first cast into a metal former. After curing, the insert was removed and machined to length. 100 formers were manufactured to cast 100 inserts at a time.
